## **Willamette Home Inspection**

## Property Inspection Report

Property address: **1068 Valley Butte Dr  
Eugene OR 97401**

Inspection date: **Monday, August 11, 2014**

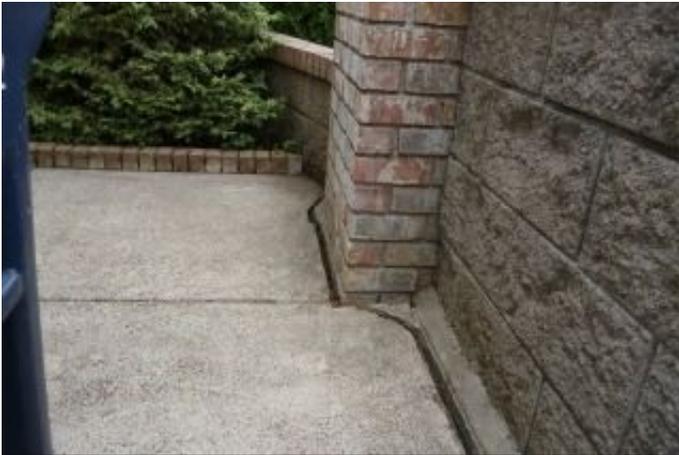
1) **Monitor** - West walk way has separated from lower retaining wall by as much as an inch, recommend monitoring for further movement.

**Photo 1-1**  
Separation at walk way and west retaining wall.

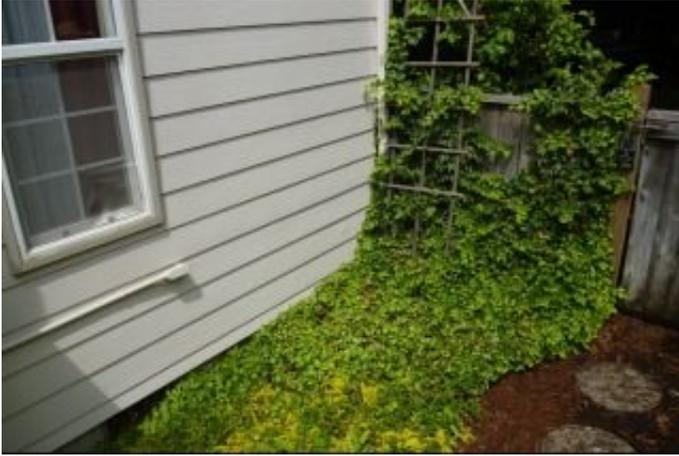
Photo 3-1

3) **Maintain** - Vegetation such as trees, shrubs and/or vines were in contact with or close to the building exterior.

Vegetation can serve as a pathway for wood-destroying insects and can retain moisture against the exterior after it rains. This is a conducive condition for wood-destroying organisms. Recommend pruning, moving or removing vegetation as necessary to maintain at least 6 inches of space between it and the building exterior. A 1-foot clearance is better.

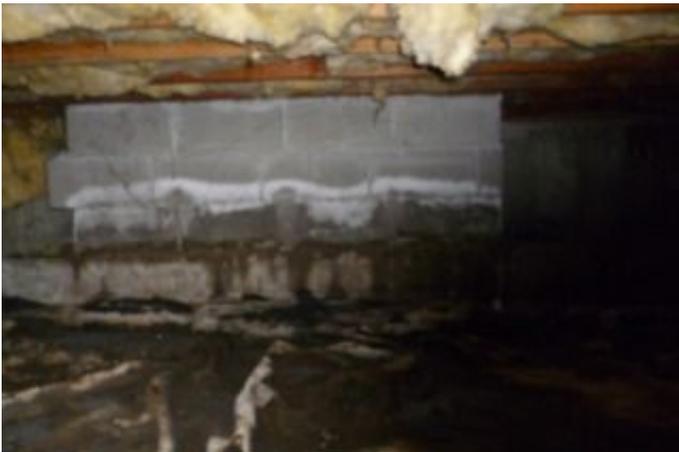
**Photo 4-1**

**4) Repair/Replace, Evaluate, Monitor** - Evidence of prior water intrusion or accumulation was found in one or more sections of the crawl space. For example, sediment stains on the vapor barrier or foundation, and/or efflorescence on the foundation. Accumulated water is a conducive condition for wood-destroying organisms and should not be present in the crawl space. Recommend that the client review any disclosure statements available and ask the property owner about past accumulation of water in the crawl space. The crawl space should be monitored in the future for accumulated water, especially after heavy and/or prolonged periods of rain. If water is found to accumulate, then recommend that a qualified contractor who specializes in drainage issues evaluate and repair as necessary. Typical repairs for preventing water from accumulating in crawl spaces include:

Standing water and efflorescence at chimney base.

- Repairing, installing or improving rain run-off systems (gutters, downspouts and extensions or drain lines)
- Improving perimeter grading
- Repairing, installing or improving underground footing and/or curtain drains

Ideally, water should not enter crawl spaces, but if water must be controlled after it enters the crawl space, then typical repairs include installing trenches, gravity drains and/or sump pump(s) in the crawl space.

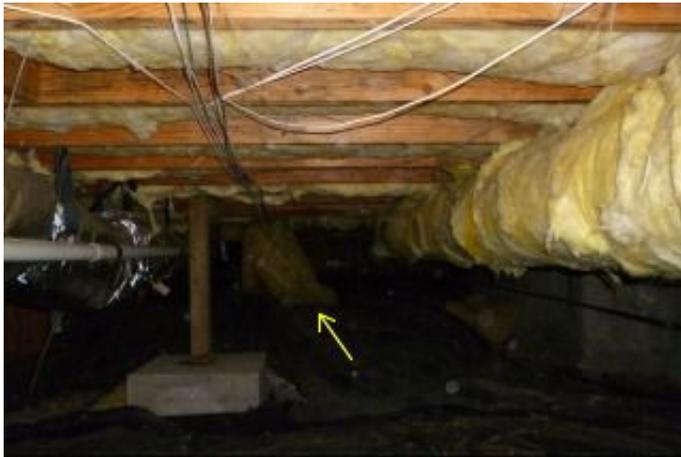
**Photo 7-1**

**7) Repair/Maintain** - Under-floor insulation was displaced in some areas, and may result in reduced energy efficiency. Recommend that a qualified person repair or replace insulation as necessary.

Displaced insulation, evident in more than one location.

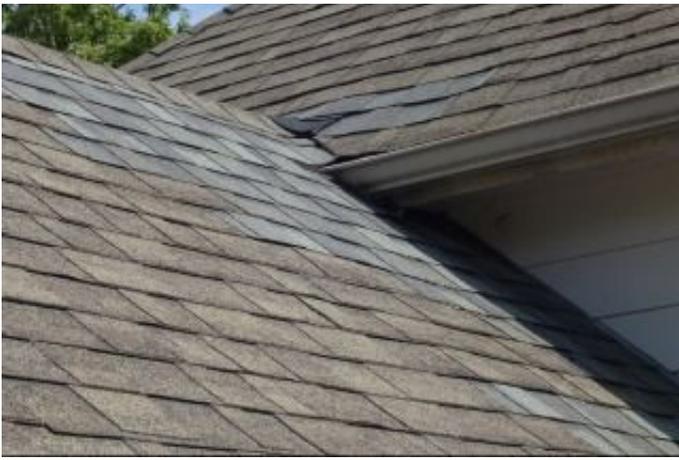
**8) Monitor** - There was evidence of previous repairs to the roof, including replaced shingles.

**Photo 8-1**  
Shingles replaced.

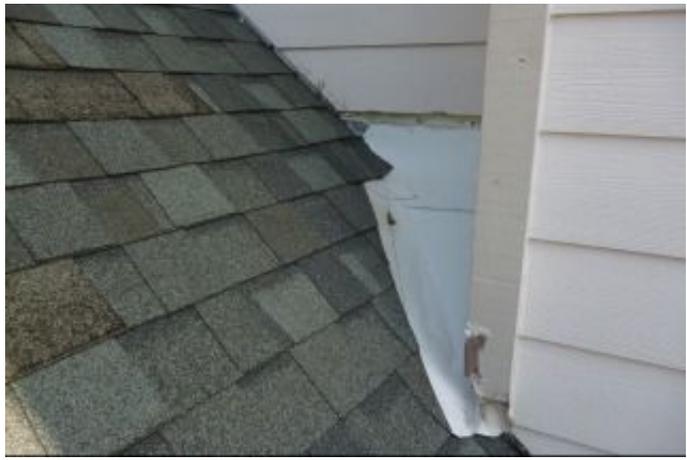
**Photo 8-2**  
Side-wall repair.

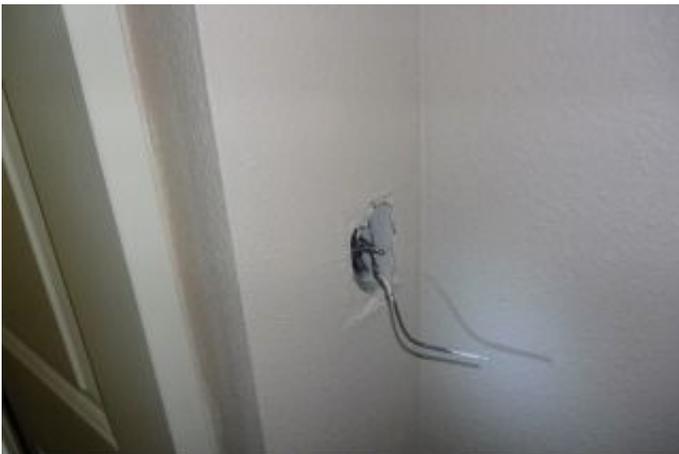
**Photo 12-1**

**12) Safety, Repair/Maintain** - There is an open box with a hot wire in it in the upstairs closet near the attic access. This appeared to be the intended switch box for attic lighting that was never completed. Recommend that a qualified professional put a wire nut on the hot wire and put a cover on the box, or finish the lighting circuit.

Open box with hot wire in closet.

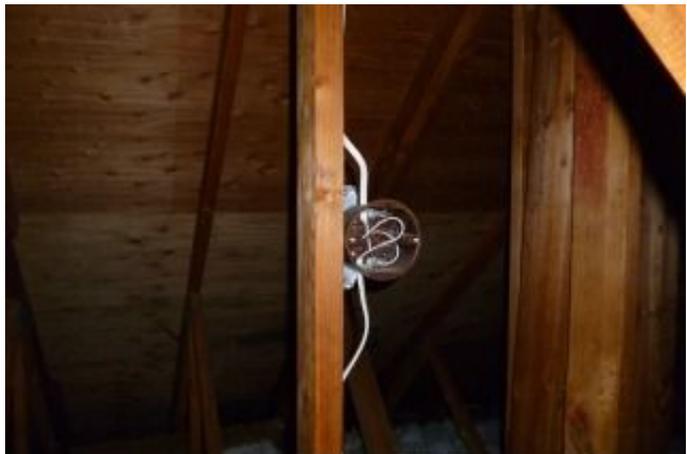
**Photo 12-2**

Unfinished circuit in attic, not live.

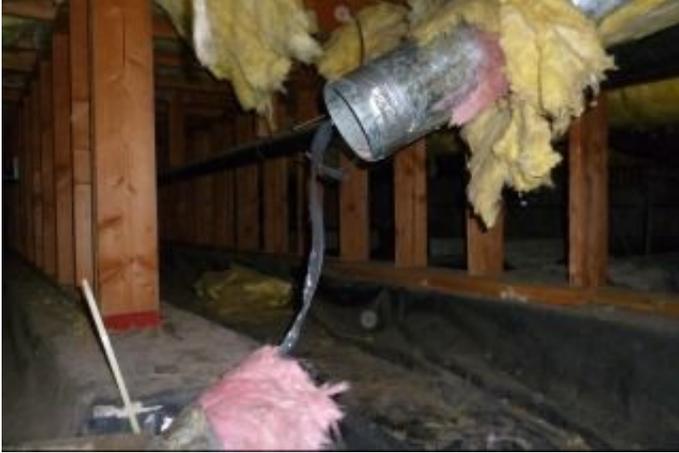
**13) Repair/Replace** - One or more heating or cooling ducts have come apart, or had significant gaps at junctions. This can result in reduced energy efficiency and increased moisture in surrounding spaces. Recommend that a qualified HVAC contractor make permanent repairs as necessary. For example, by securely supporting ducts and installing approved tape or mastic at seams.

**Photo 13-1**  
Disconnected supply duct in crawl-space.

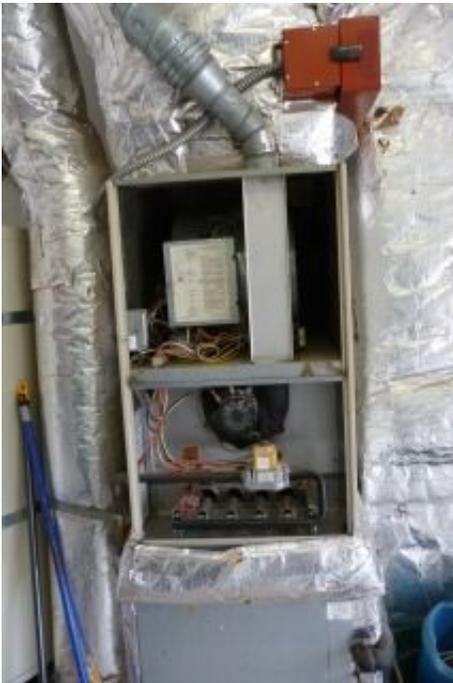
**14) Comment** - The estimated useful life for most forced air furnaces is 15-20 years. This furnace appeared to be this age and/or its useful lifespan and may need replacing or significant repairs at any time. Recommend budgeting for a replacement in the near future.

**Photo 14-1**  
Furnace with cover off.

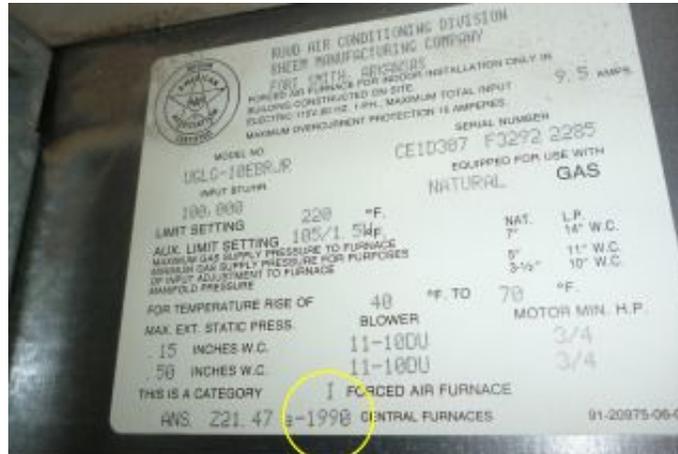
**Photo 14-2**  
Label with date of manufacture.

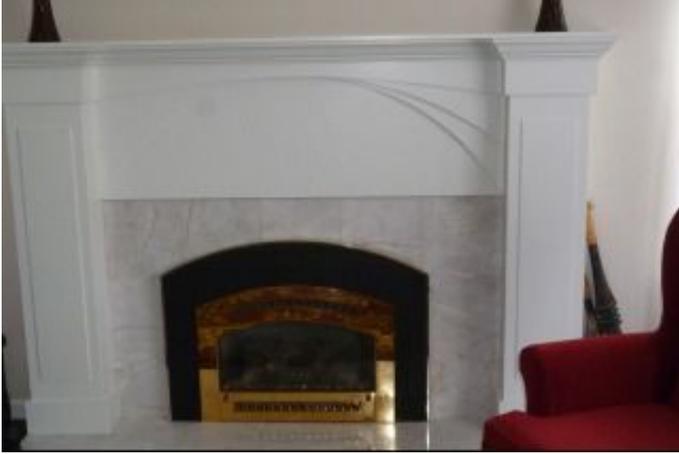
**Photo 15-1**

**15) Repair/Replace, Evaluate** - The gas fireplace or stove was not fully evaluated because the pilot light was off. The

inspector only operates normal controls (e.g. on/off switch or thermostat) and does not light pilot lights or operate gas shut-off valves. Recommend that the client review all documentation for such gas appliances and familiarize themselves with the lighting procedure. If necessary, a qualified specialist should assist in lighting such appliances, and make any needed repairs.

Gas fireplace non functioning.
