Willamette Home Inspection

Summary

Property address: **1068 Valley Butte Dr
Eugene OR 97401**

Inspection date: **Monday, August 11, 2014**

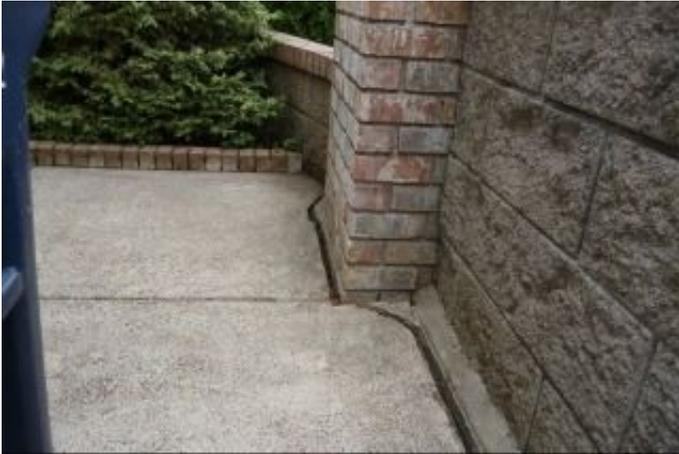
1 Monitor - West walk way has separated from lower retaining wall by as much as an inch, recommend monitoring for further movement.

Photo 1-1
Separation at walk way and west retaining wall.

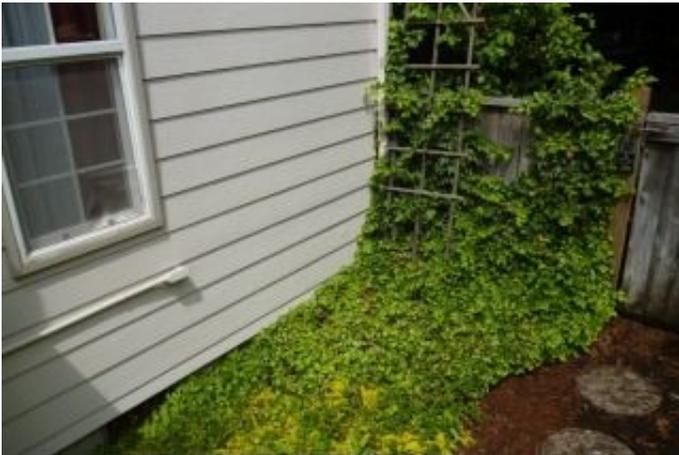
Photo 3-1

3 Maintain - Vegetation such as trees, shrubs and/or vines were in contact with or close to the building exterior. Vegetation can serve as a pathway for wood-destroying insects and can retain moisture against the exterior after it rains. This is a conducive condition for wood-destroying organisms. Recommend pruning, moving or removing vegetation as necessary to maintain at least 6 inches of space between it and the building exterior. A 1-foot clearance is better.

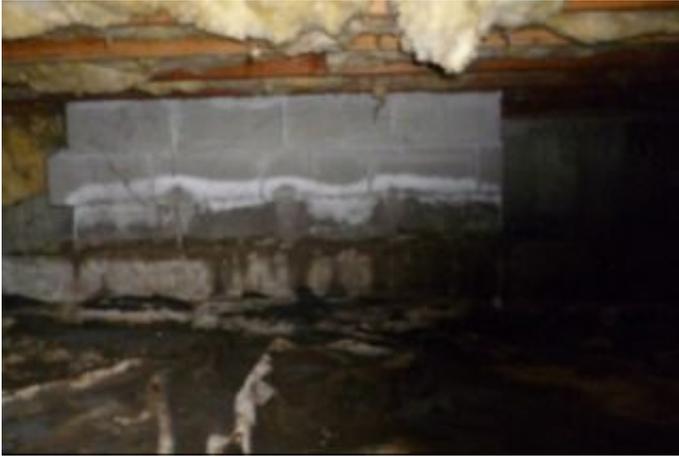
4 Repair/Replace, Evaluate, Monitor - Evidence of prior water intrusion or accumulation was found in one or more sections of the crawl space. For example, sediment stains on the vapor barrier or foundation, and/or efflorescence on the foundation. Accumulated water is a conducive condition for wood-destroying organisms and should not be present in the crawl space. Recommend that the client review any disclosure statements available and ask the property owner about past accumulation of water in the crawl space. The crawl space should be monitored in the future for accumulated water, especially after heavy and/or prolonged periods of rain. If water is found to accumulate, then recommend that a qualified contractor who specializes in drainage issues evaluate and repair as necessary. Typical repairs for preventing water from

Photo 4-1
Standing water and efflorescence at chimney base.

- Repairing, installing or improving rain run-off systems (gutters, downspouts and extensions or drain lines)
- Improving perimeter grading
- Repairing, installing or improving underground footing and/or curtain drains

Ideally, water should not enter crawl spaces, but if water must be controlled after it enters the crawl space, then typical repairs include installing trenches, gravity drains and/or sump pump(s) in the crawl space.

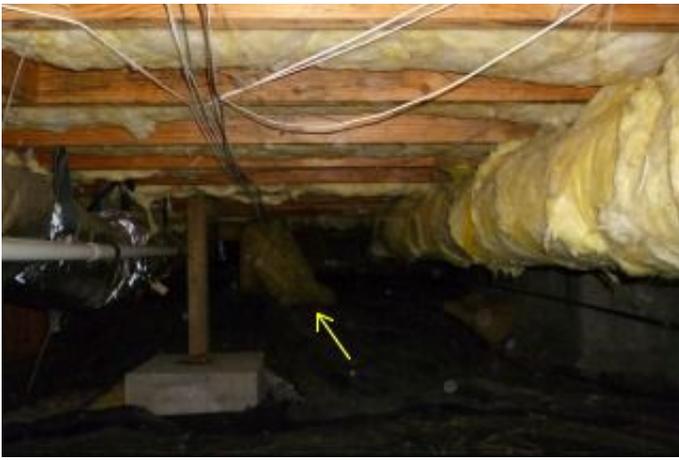
7 Repair/Maintain - Under-floor insulation was displaced in some areas, and may result in reduced energy efficiency. Recommend that a qualified person repair or replace insulation as necessary.

Photo 7-1
Displaced insulation, evident in more than one location.

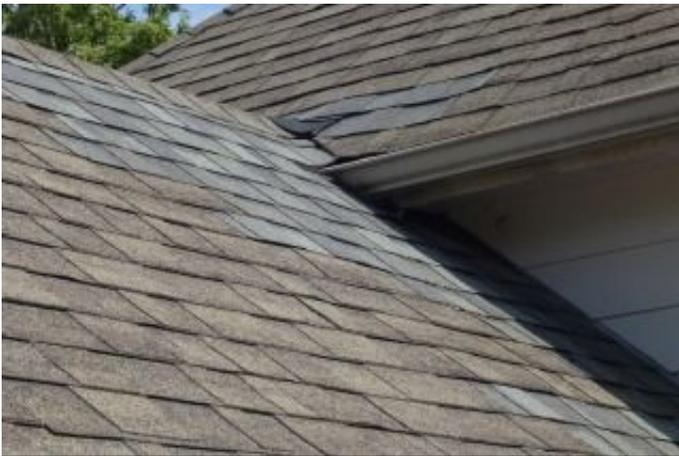
8 Monitor - There was evidence of previous repairs to the roof, including replaced shingles.

Photo 8-1
Shingles replaced.

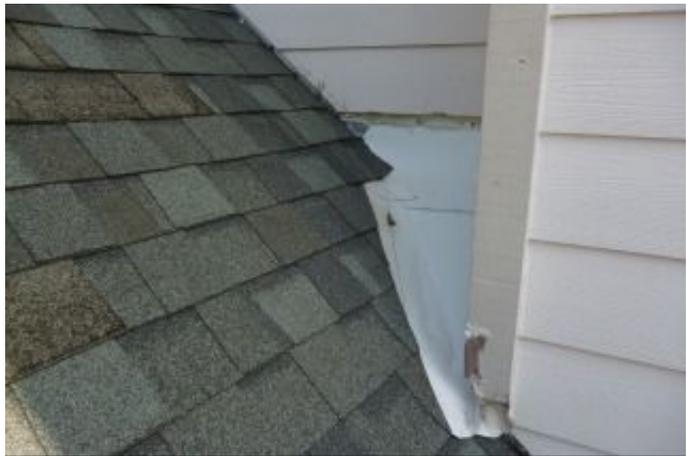
Photo 8-2
Side-wall repair.

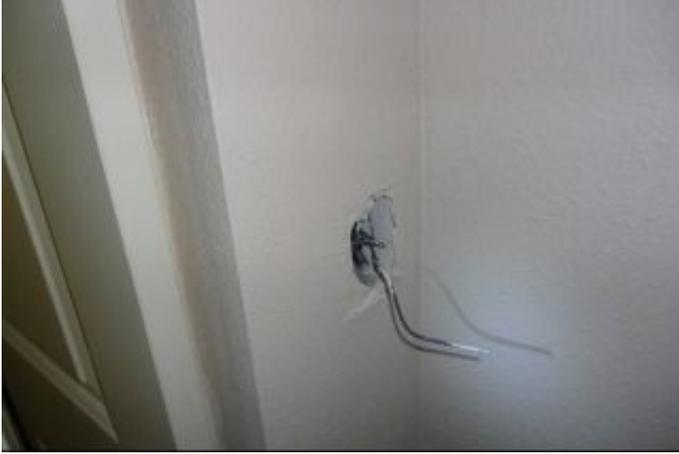
12 Safety, Repair/Maintain - There is an open box with a hot wire in it in the upstairs closet near the attic access. This appeared to be the intended switch box for attic lighting that was never completed. Recommend that a qualified professional put a wire nut on the hot wire and put a cover on the box, or finish the lighting circuit.

Photo 12-1
Open box with hot wire in closet.

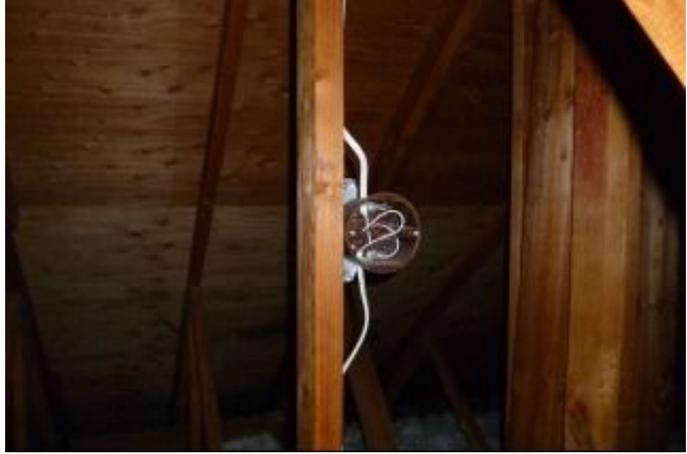
Photo 12-2
Unfinished circuit in attic, not live.

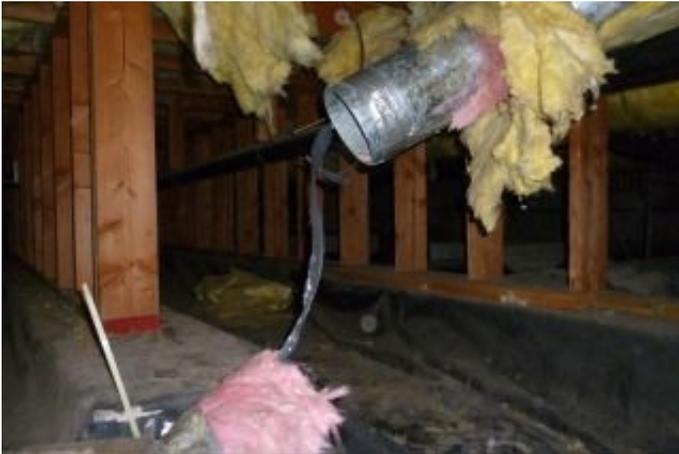
13 Repair/Replace - One or more heating or cooling ducts have come apart, or had significant gaps at junctions. This can result in reduced energy efficiency and increased moisture in surrounding spaces. Recommend that a qualified HVAC contractor make permanent repairs as necessary. For example, by securely supporting ducts and installing approved tape or mastic at seams.

Photo 13-1
Disconnected supply duct in crawl-space.

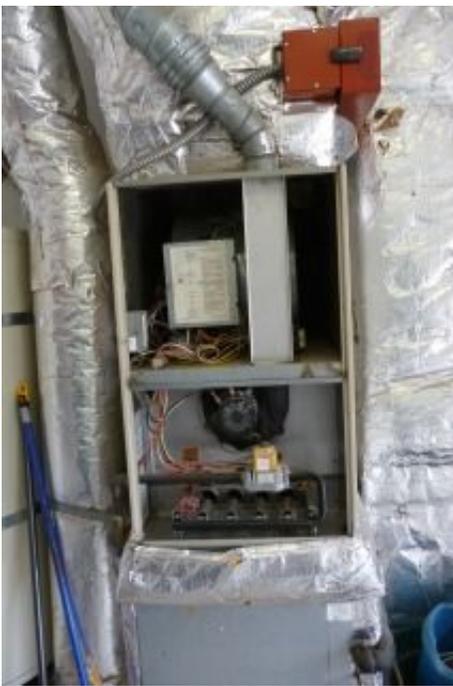
14 Comment - The estimated useful life for most forced air furnaces is 15-20 years. This furnace appeared to be this age and/or its useful lifespan and may need replacing or significant repairs at any time. Recommend budgeting for a replacement in the near future.

Photo 14-1
Furnace with cover off.

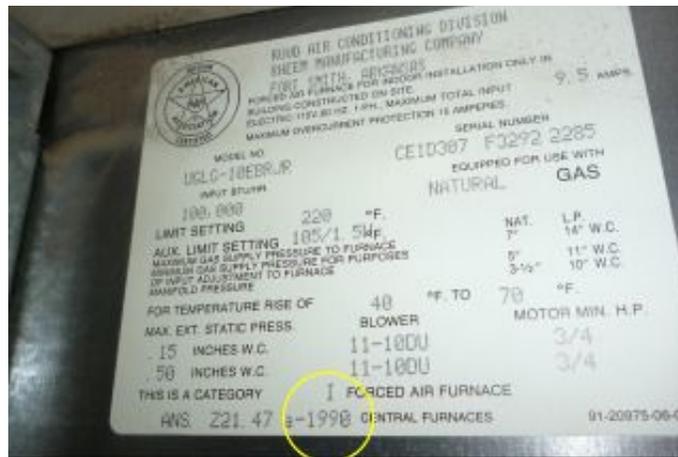
Photo 14-2
Label with date of manufacture.

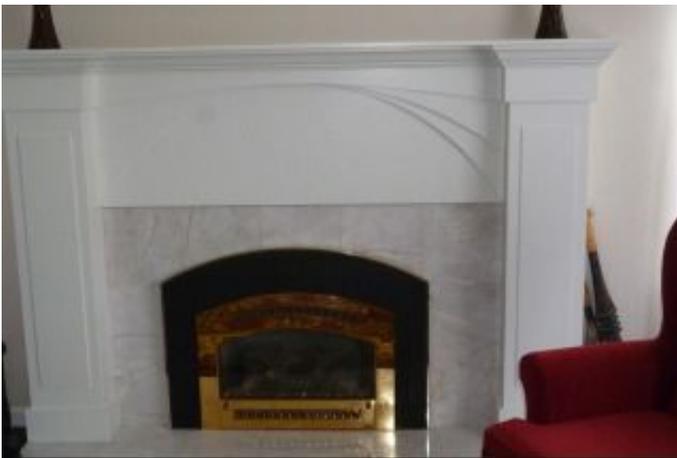
15 Repair/Replace, Evaluate - The gas fireplace or stove was not fully evaluated because the pilot light was off. The inspector only operates normal controls (e.g. on/off switch or thermostat) and does not light pilot lights or operate gas shut-off valves. Recommend that the client review all documentation for such gas appliances and familiarize themselves with the lighting procedure. If necessary, a qualified specialist should assist in lighting such appliances, and make any needed repairs.

Photo 15-1
Gas fireplace non functioning.
