## **Willamette Home Inspection**

### Summary

Property address: **1084 McKinley Street**

Inspection date: **Wednesday, September 17, 2014**

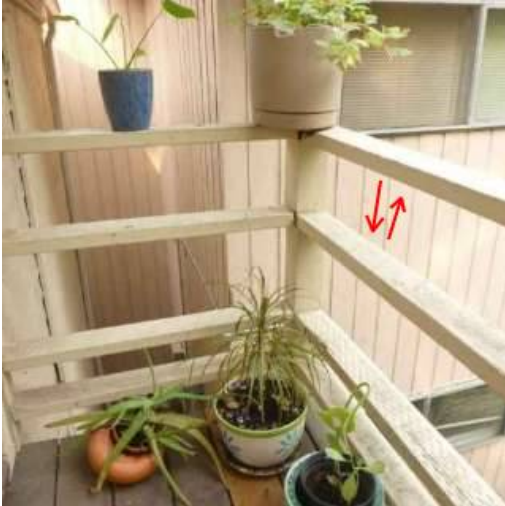
1) **Safety, Repair/Replace** - Handrails at one or more flights of stairs were too low or too high and pose a fall hazard. Handrails should be located at least 34 inches and at most 38 inches above the nose of each tread/riser. Recommend that a qualified person repair per standard building practices. Handrail at second floor unit is too low.

2) **Safety, Repair/Replace** - Guardrails at one or more locations with drop-offs higher than 30 inches had gaps that were too large. This poses a safety hazard for children (e.g. falling, getting stuck in railing). Guardrails should not have gaps or voids that allow passage of a sphere equal to or greater than 4 inches in diameter, or 6 inches in diameter at triangular spaces between stair edges and guardrails. Recommend that a qualified contractor repair or replace guardrails per standard building practices.

Photo 2-1 Guardrail and handrail at second floor apartment does not meet current codes.

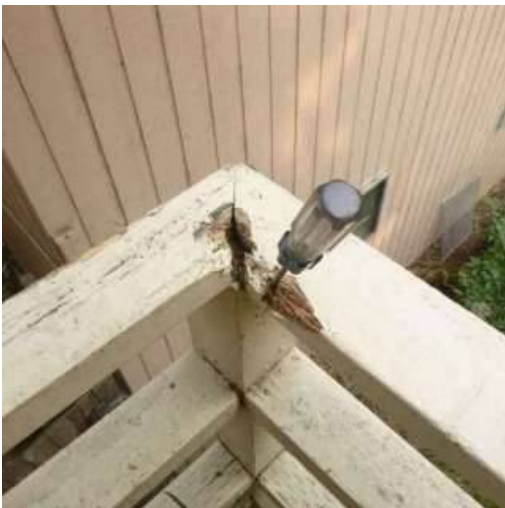
Photo 3-1

3) **Repair/Replace, Evaluate** - Fungal rot was found in railings at one or more sets of exterior stairs. Fungal rot in some stair components may pose a safety hazard. Recommend that a qualified person evaluate and repair as necessary. All rotten wood should be replaced.

Fungal rot was found in the rail at second floor unit.

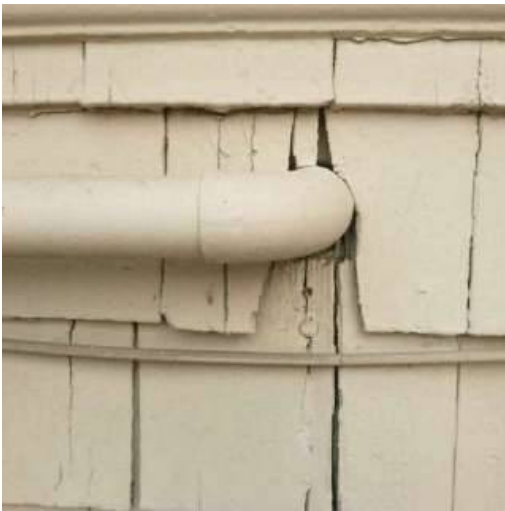
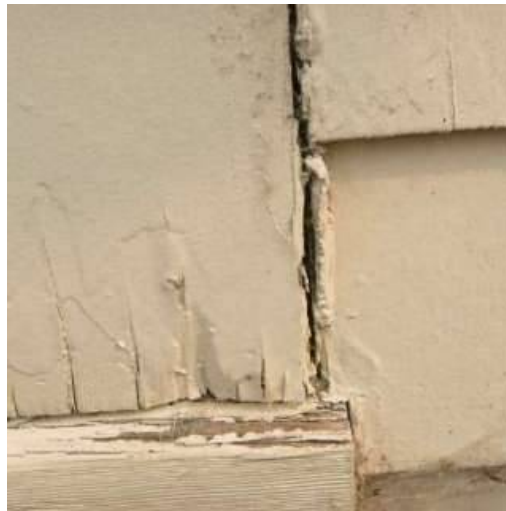
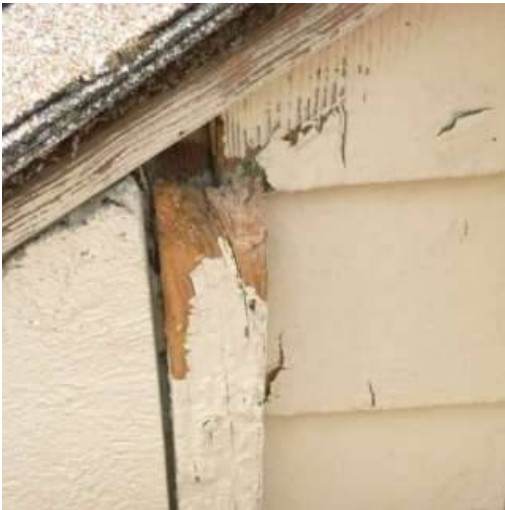
5) **Repair/Replace** - Some sections of siding and/or trim were deteriorated, loose, split and/or damaged. Recommend that a qualified person repair, replace or install siding or trim as necessary.

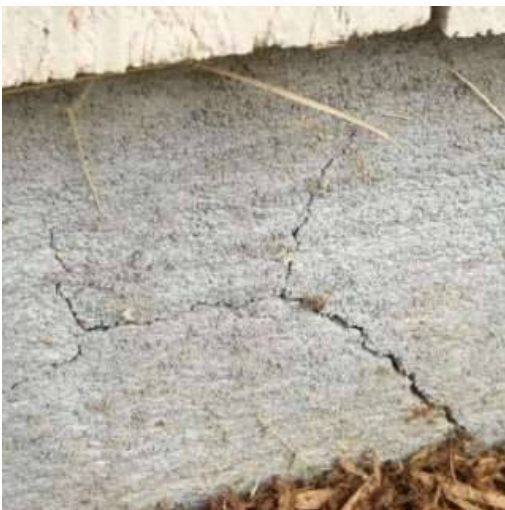
Photo 6-1

**6) Repair/Maintain** - One or more cracks were found in the foundation. Due to the age of this structure these did not appear to be a structural concern, but recommend sealing them to prevent water infiltration and monitor them in the future. Numerous products exist to seal such cracks including hydraulic cement, non-shrinking grout, resilient caulks and epoxy sealants.

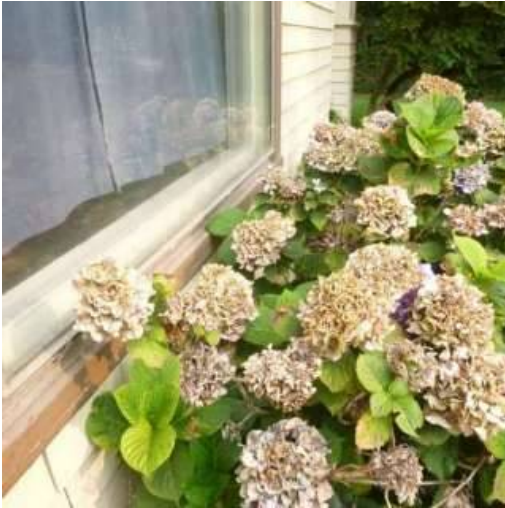
Photo 7-1

**7) Maintain** - Vegetation such as trees, shrubs and/or vines was in contact with or close to the building exterior. Vegetation can serve as a pathway for wood-destroying insects and can retain moisture against the exterior after it rains. Recommend pruning, moving or removing vegetation as necessary to maintain at least 6 inches of space between it and the building exterior. A 1-foot clearance is better.

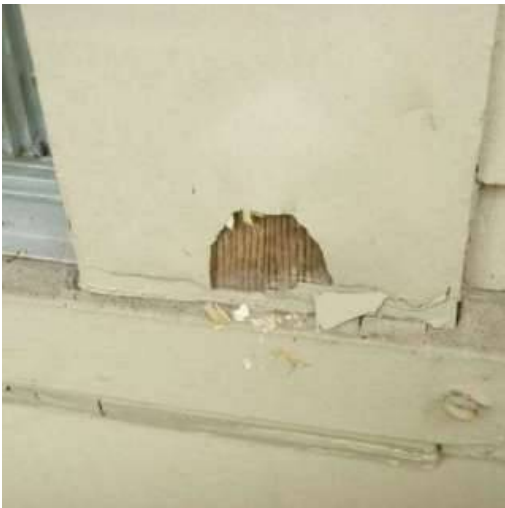
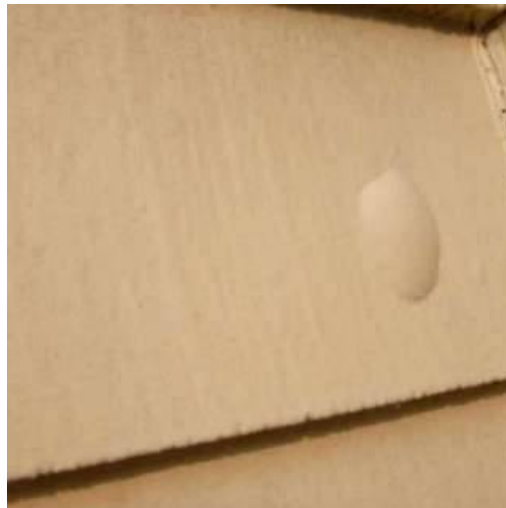
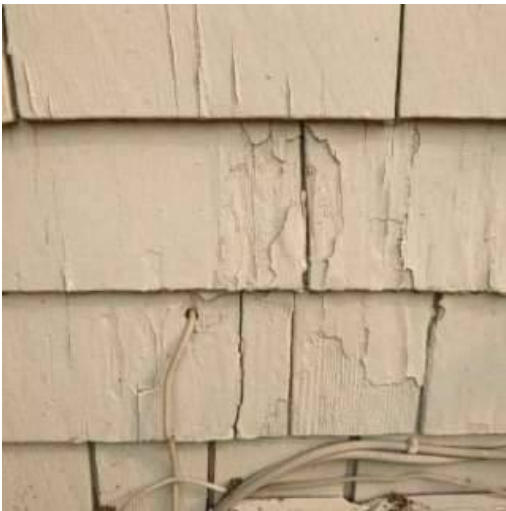
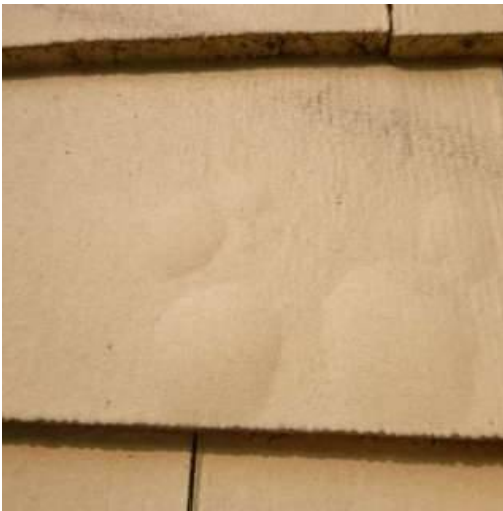
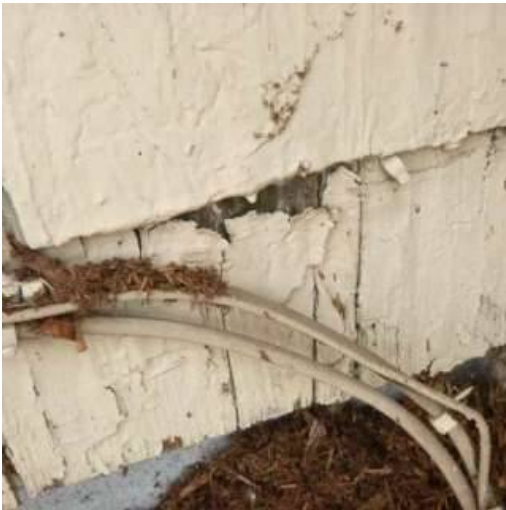
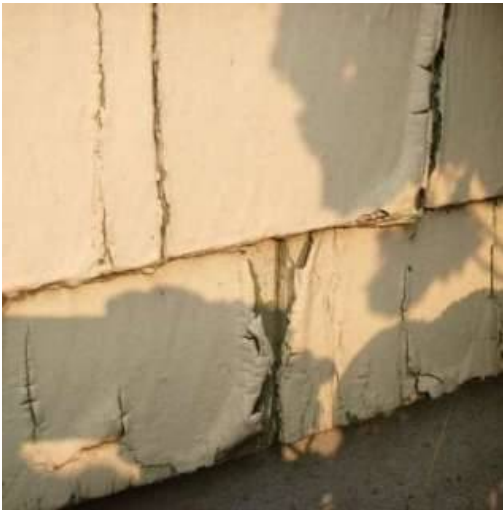
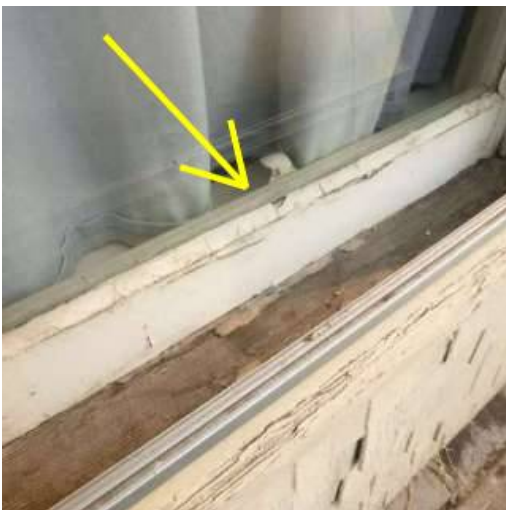
**8) Maintain** - The paint or stain finish in some areas was failing (e.g. peeling, faded, worn, thinning). Siding and trim with a failing finish can be damaged by moisture. Recommend that a qualified contractor prep (e.g. clean, scrape, sand, prime, caulk) and repaint or restain the building exterior where necessary and per standard building practices. Any repairs needed to the siding or trim should be made prior to this.

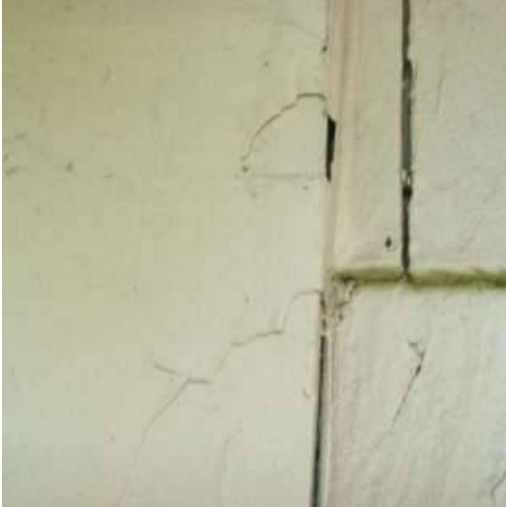
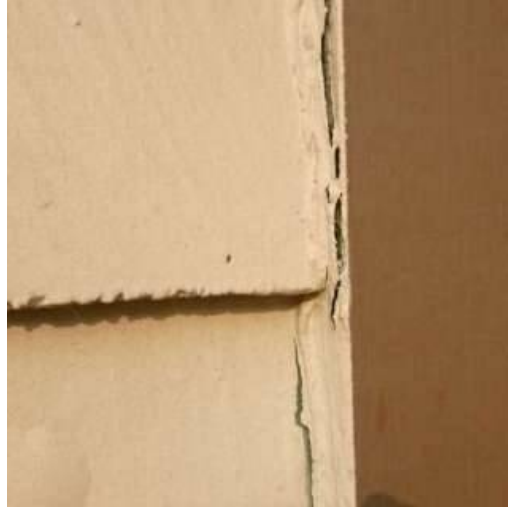
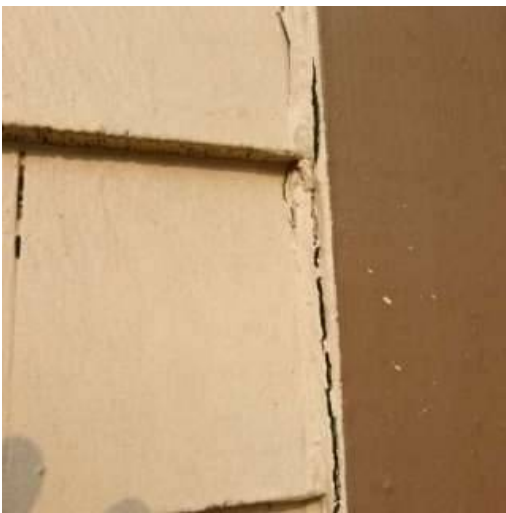
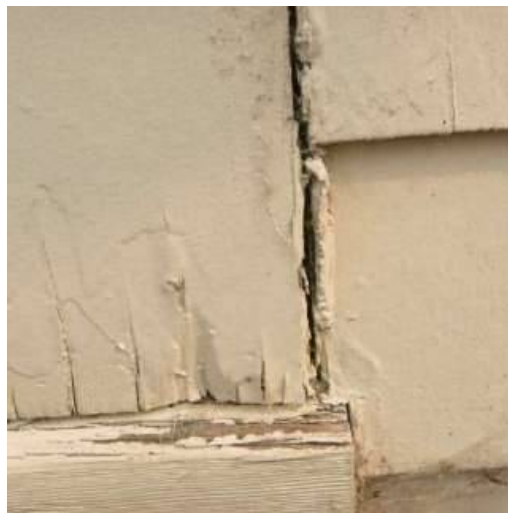
**9) Maintain** - Caulk was missing and/or deteriorated in some areas. For example, around windows, at siding-trim junctions and/or at wall penetrations. Recommend that a qualified person renew or install caulk as necessary. Where gaps are wider than 1/4 inch, an appropriate material other than caulk should be used. For more information, visit:

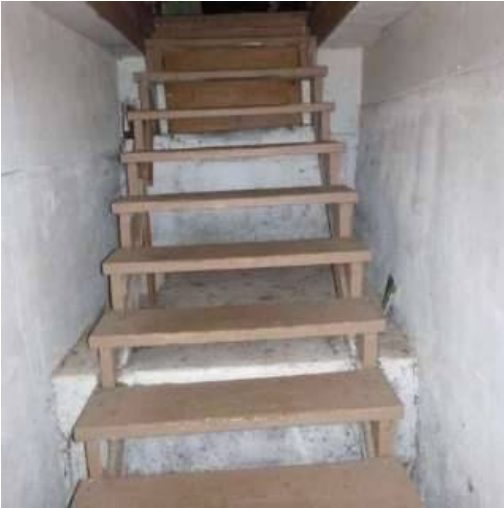
Photo 12-1

12) **Safety, Repair/Replace** - Handrails at one or more flights of stairs were missing. This is a potential fall hazard. Handrails should be installed at stairs with four or more risers or where stairs are greater than 30 inches high. Recommend that a qualified contractor install handrails where missing and per standard building practices.

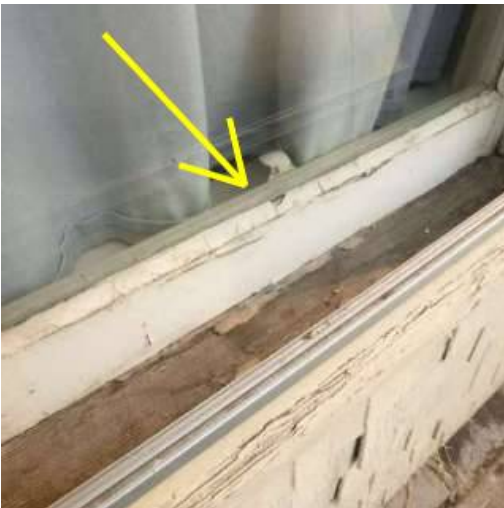
Photo 13-1

13) **Maintain** - The glazing compound or caulk that holds glass panes in one or more windows was deteriorated and/or substandard. Air and/or water can leak through windows, and wood window frames are prone to rot. Recommend that a qualified person replace glazing compound as necessary. For more information, visit:

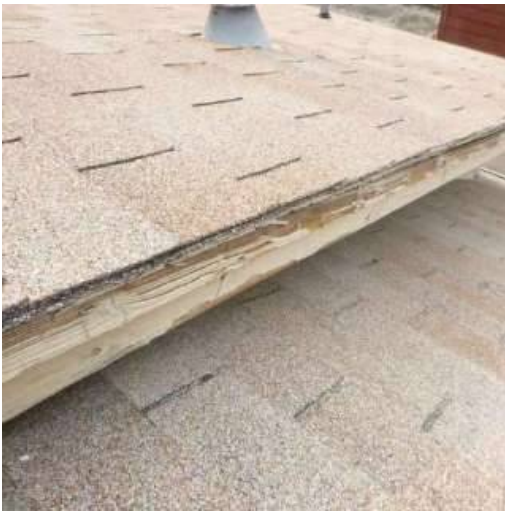
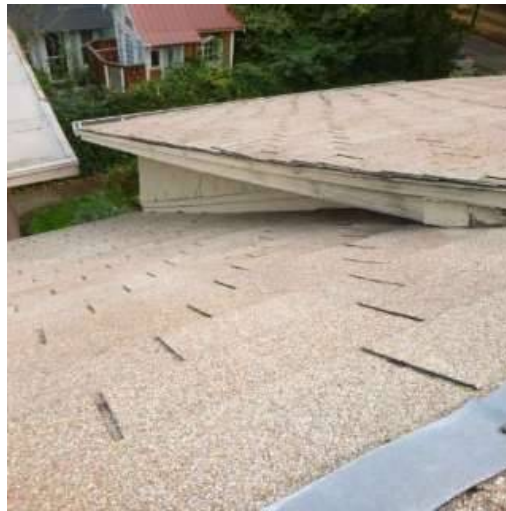
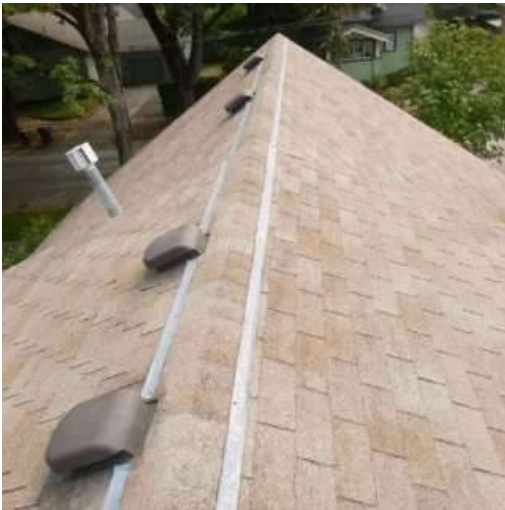
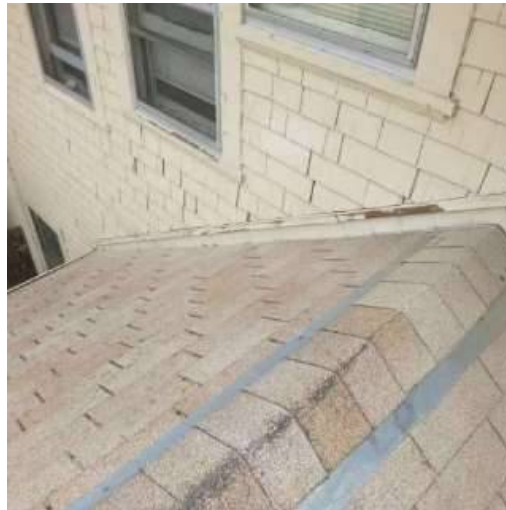
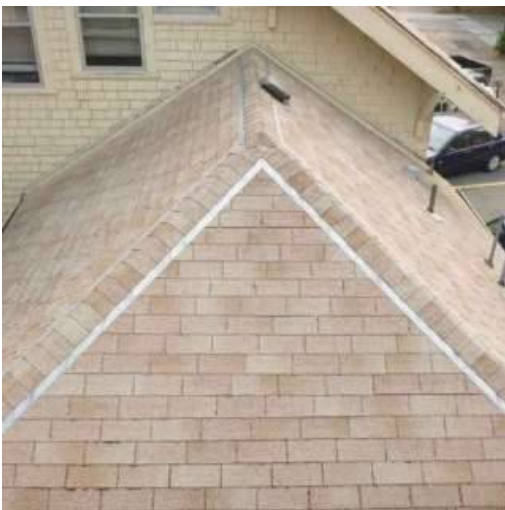
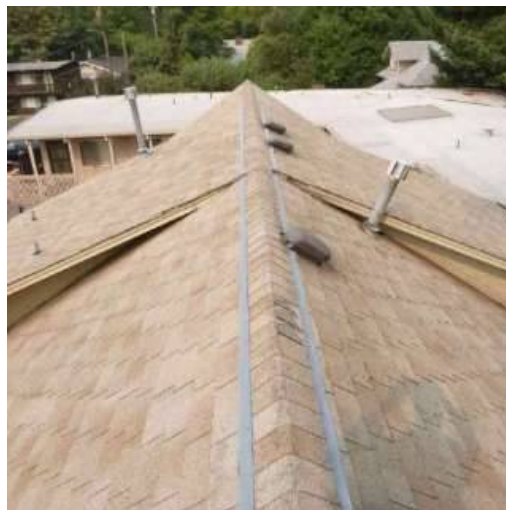
15) **Major Defect, Evaluate** - The roof surface appeared to be near the end of its service life and will likely need replacing in the near future even if repairs are made now. Recommend discussing replacement options with a qualified contractor, and budgeting for a replacement roof surface in the near future.

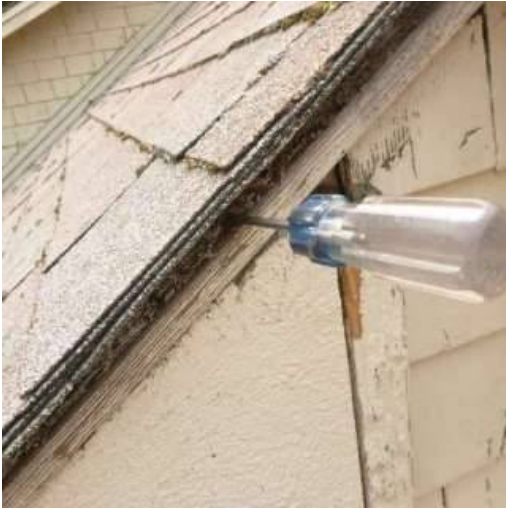
**16) Repair/Replace** - Fungal rot or significant water damage was found at one or more roof areas at edges of roof sheathing and/or barge trim. Recommend that a qualified contractor repair as necessary. For example, by replacing all rotten wood, priming and painting new wood and installing flashing.

**Photo 16-1** Fungal rot, roof sheathing, West side.

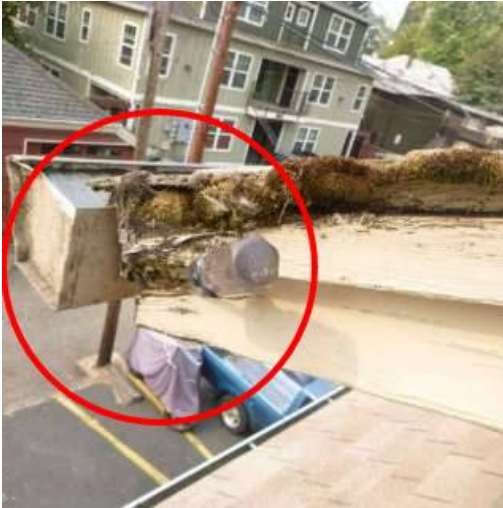
**Photo 16-2** Fungal rot, barge trim board.

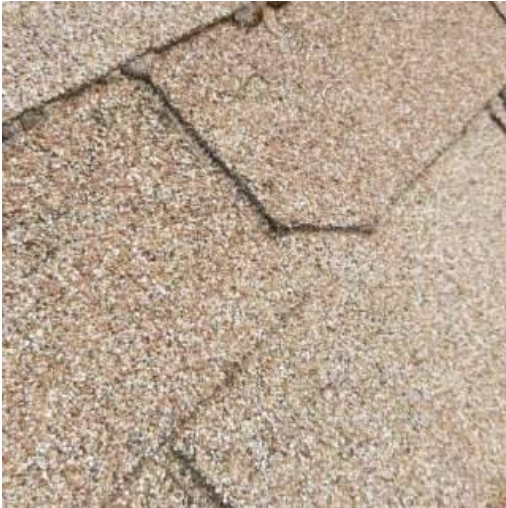
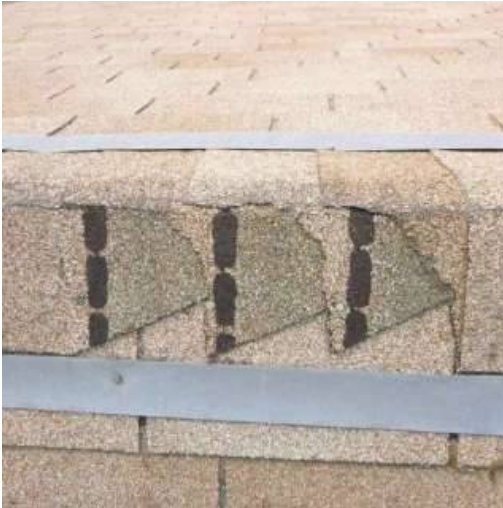
**17) Repair/Replace** - Some composition shingles were broken and/or damaged. Leaks can occur as a result. Recommend that a qualified contractor repair as necessary. For example, by replacing shingles.

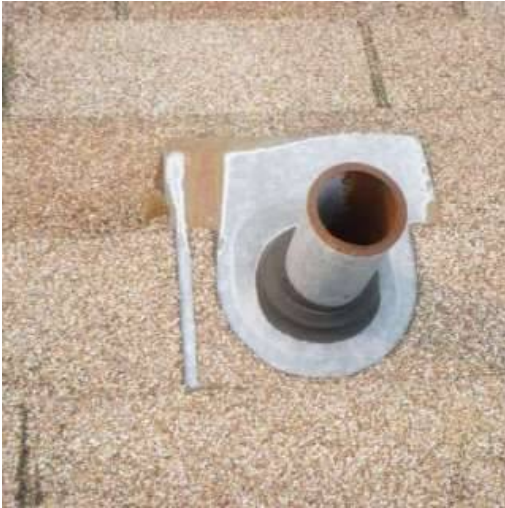
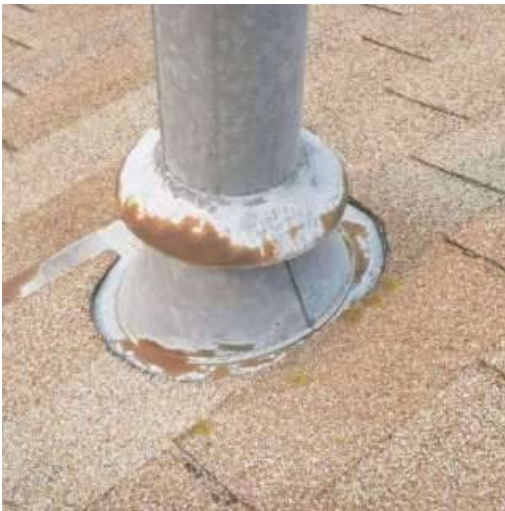
**18) Repair/Maintain** - One or more roof-top appurtenances such as vents, masts, pipes, etc. were corroded. Metal may deteriorate to the point of needing replacement. Leaks can occur around such items if flashing or sealant doesn't form a waterproof seal with the corroded metal. Recommend that a qualified person repair as necessary. For example, by cleaning rust and repainting with a rust-inhibiting paint.

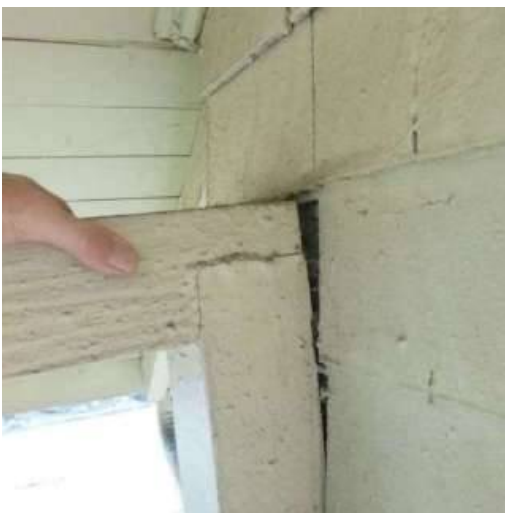
Photo 19-1

19) **Repair/Maintain** - Loose knee brace observed at East gable end.

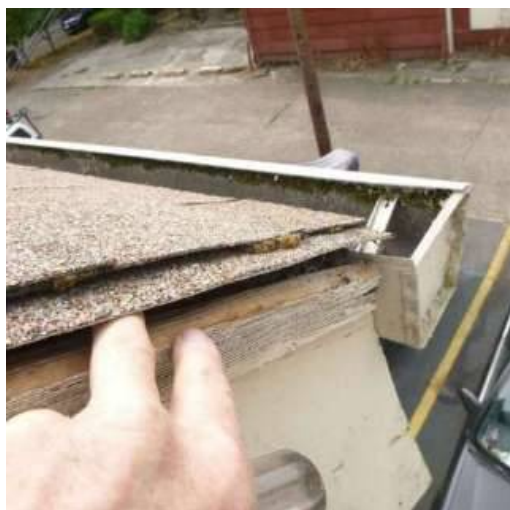
**Photo 20-1**

20) **Repair/Maintain** - Loose gable trim, West side.

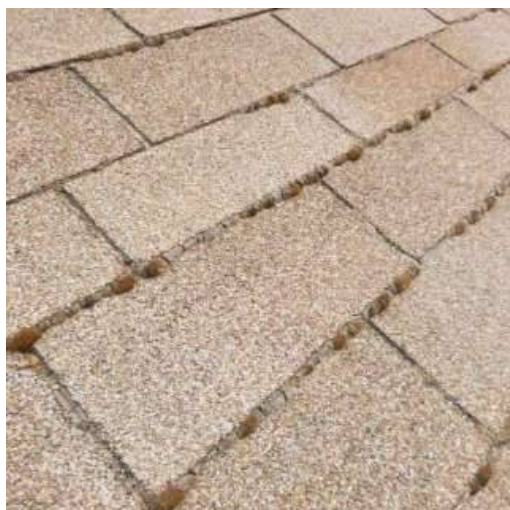
**Photo 21-1**

**21) Maintain** - Some moss was growing on the roof. As a result, shingles can lift or be damaged. Leaks can result and/or the roof surface can fail prematurely. Efforts should be made to kill the moss during its growing season (wet months). Typically, zinc or phosphate-based chemicals are used for this and must be applied periodically. For information on various moss treatment products and their pros and cons, visit:

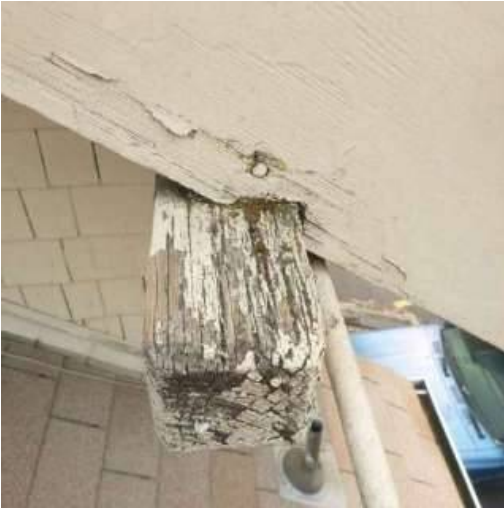
Photo 22-1

**22) Maintain** - Protruding brace ends should be sealed and painted.

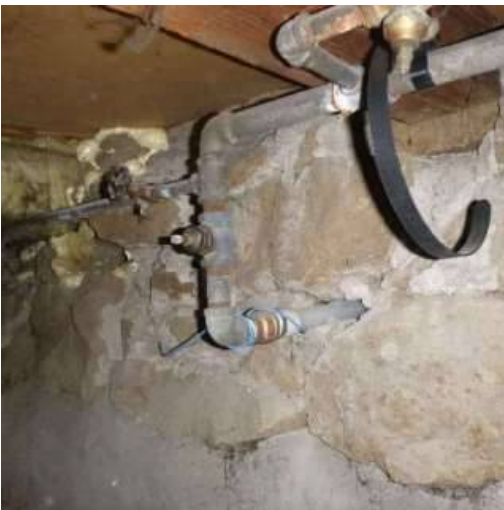
Photo 25-1

**25) Evaluate, Monitor** - Some or all of the water supply and drain or vent pipes were made of galvanized steel. Based on the age of this structure and the 40-60 year useful life of this piping, it will likely need replacing in the future. Leaks can develop, flooding and/or water damage may occur, flow can be restricted due to scale accumulating inside the piping, and water may be rusty. Note that it is beyond the scope of this inspection to determine what percentage of the piping is older, galvanized steel, as much of it is concealed in wall, floor and/or ceiling cavities. Recommend the following:

- That a qualified plumber evaluate to better understand or estimate the remaining life
- Consulting with a qualified plumber about replacement options and costs
- Budget for replacement in the future
- Monitor these pipes for leaks and decreased flow in the future
- Consider replacing old, galvanized steel piping proactively

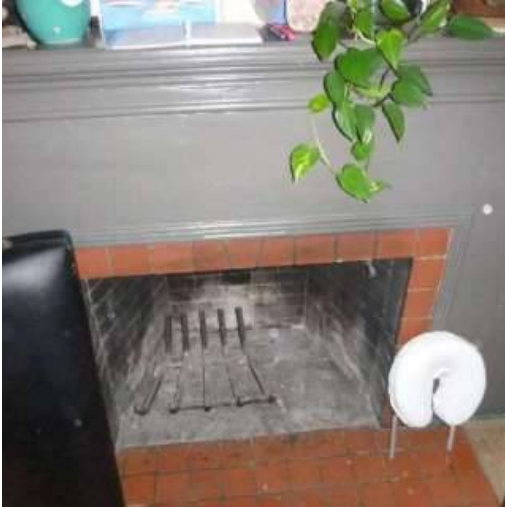
Photo 27-1

**27) Safety, Repair/Maintain, Evaluate** - One or more wood-burning fireplaces or stoves were found at the property. When such devices are used, they should be professionally inspected and cleaned annually to prevent creosote build-up and to determine if repairs are needed. The National Fire Protection Association states that a "Level 2" chimney inspection should be performed with every sale or transfer of property with a wood-burning device. Recommend consulting with the property owner about recent and past servicing and repairs to all wood-burning devices and chimneys or flues at this property. Recommend that a qualified specialist evaluate all wood-burning devices and chimneys, and clean and repair as necessary. Note that if a wood stove insert is installed, it may need to be removed for such an evaluation. For more information, search for "chimney inspection" at:

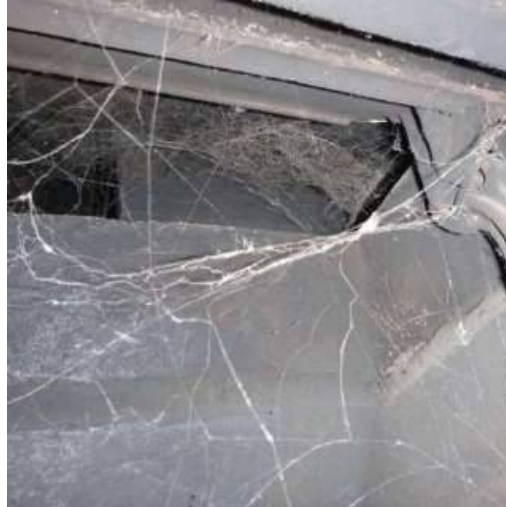
Photo 27-2 Damper was functional.

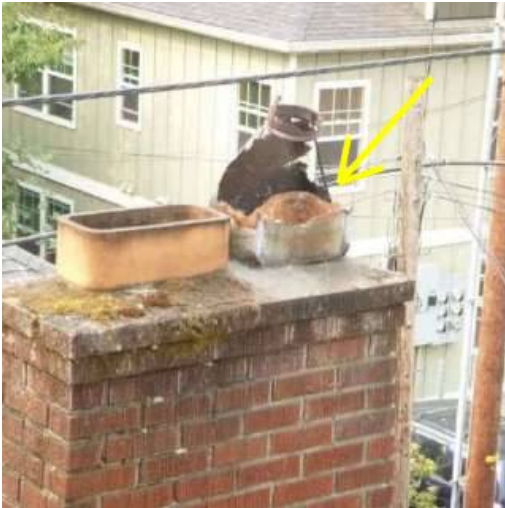
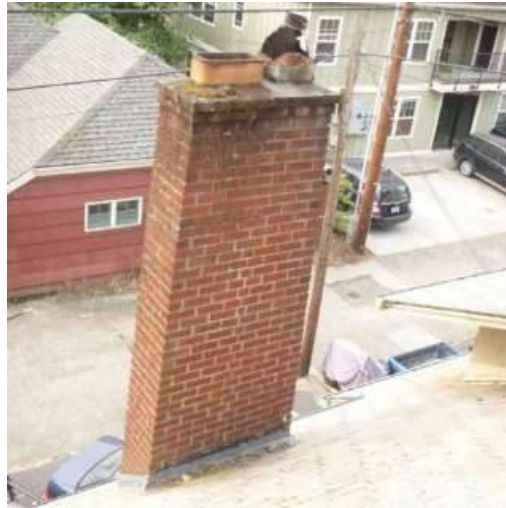
**28) Repair/Replace** - Metal flue and/or chimney cap is deteriorated, recommend a qualified person repair or replace as necessary. If chimney is not to be used it should be sealed at crown and fire box.

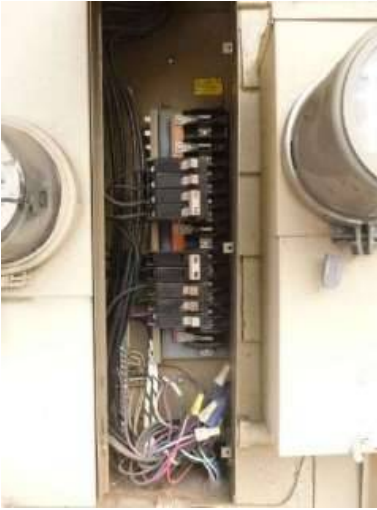
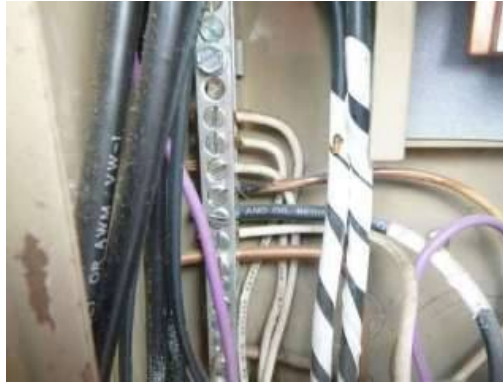
**29) Safety, Repair/Replace, Evaluate** - One or more wires were scorched or heat-damaged in panel(s) #A. A qualified electrician should evaluate and make repairs or replace components as necessary.

A wire at the neutral bar has scorched insulation.

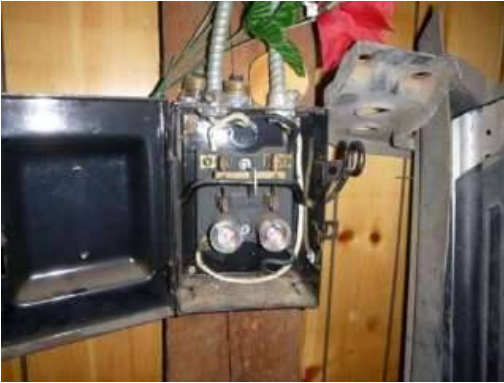
Photo 30-1

**30) Safety, Repair/Replace, Evaluate** - Panel(s) #D used older style, "Edison" base fuses. This type of fuse allows anyone to install incorrectly rated fuses, possibly resulting in damage to wiring. Recommend that a qualified electrician evaluate this panel and the wiring to determine if damage has occurred, and repair or replace components and/or wiring as necessary.

A basement service disconnect is a screw in fuse type.

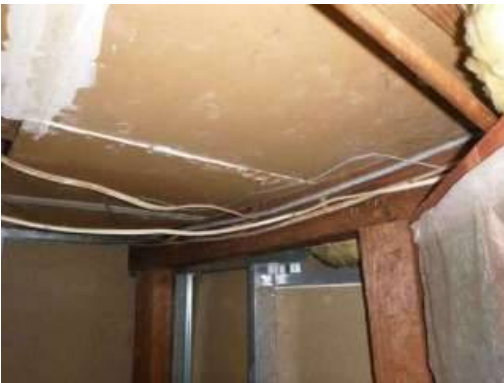
Photo 31-1

**31) Safety, Repair/Replace** - Non-metallic sheathed wiring was installed at one or more locations, and was subject to damage such as on easily accessible wall or ceiling surfaces. The insulation can be damaged by objects coming in contact with it, resulting in exposed, energized wires. Also, copper conductors can break after being repeatedly moved or bent. This is a potential shock or fire hazard. Recommend that a qualified electrician repair per standard building practices. For example, by installing protective conduit or re-routing wires through walls or ceilings. Exposed wire is present in the basement.

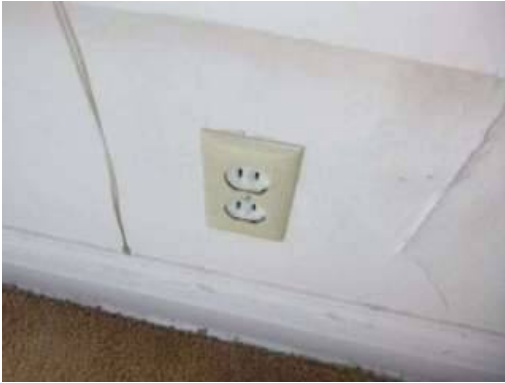
Photo 32-1

**32) Safety, Evaluate** - 2-slot receptacles (outlets) rather than 3-slot, grounded receptacles were installed in one or more areas. These do not have an

equipment ground and are considered unsafe by today's standards. Appliances that require a ground should not be used with 2-slot receptacles. Examples of such appliances include computers and related hardware, refrigerators, freezers, portable air conditioners, clothes washers, aquarium pumps, and electrically operated gardening tools. The client should be aware of this limitation when planning use for various rooms, such as an office. Upgrading to grounded receptacles typically requires installing new wiring from the main service panel or sub-panel to the receptacle(s), in addition to replacing the receptacle(s). Consult with a qualified electrician about upgrading to 3-wire, grounded circuits.

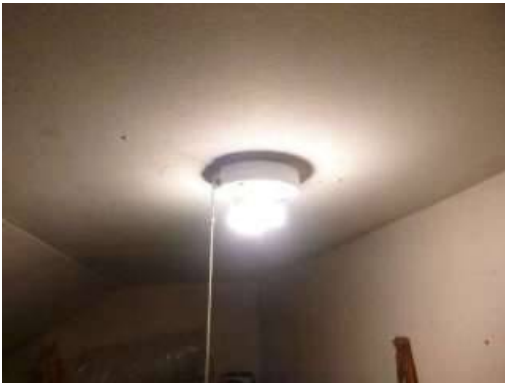
Photo 33-1

**33) Safety, Comment** - Light fixtures with fully or partially exposed fluorescent bulbs were installed in one or more closets. This is a safety hazard. Recommend that protective sleeves be installed on such bulbs to prevent breakage. The upstairs storage closet has an exposed bulb and the pull chain switch operates poorly.

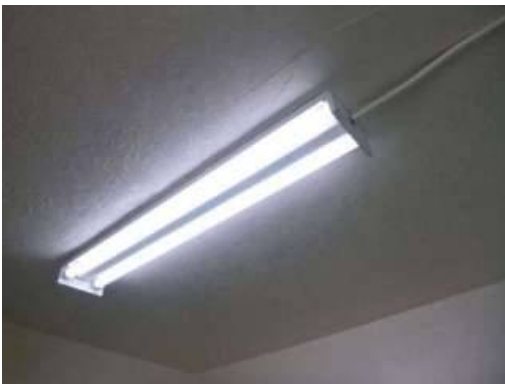
Photo 34-1

**34) Repair/Replace** - One or more globes or covers for light fixtures were missing or damaged. Recommend replacing as necessary to avoid exposed bulbs. With closet lighting or where flammable stored objects are near light fixtures, missing or broken covers can be a fire hazard. A diffuser is missing in the living room of the upstairs apartment.

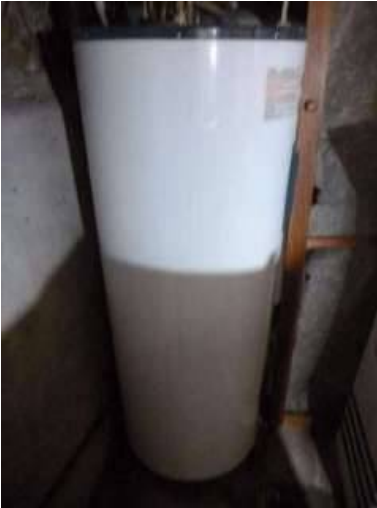
Photo 37-1

**37) Safety, Repair/Replace** - The water heater did not have earthquake straps or struts installed. This is a potential safety hazard in the event of an earthquake due to the risk of the water heater tipping over, gas lines breaking if it's gas-fired, or electric wiring being damaged if powered by electricity.

Neither water heater is strapped.

Leaks can also occur in water-supply pipes. Recommend that a qualified person install earthquake straps or struts as necessary and per standard building practices.

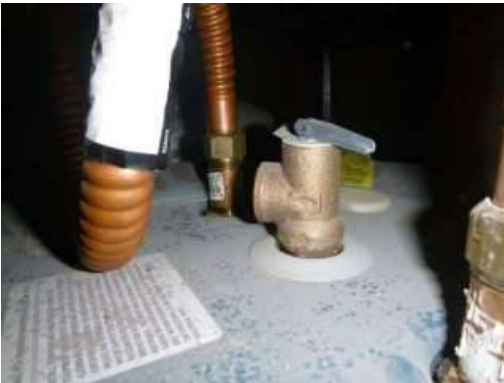
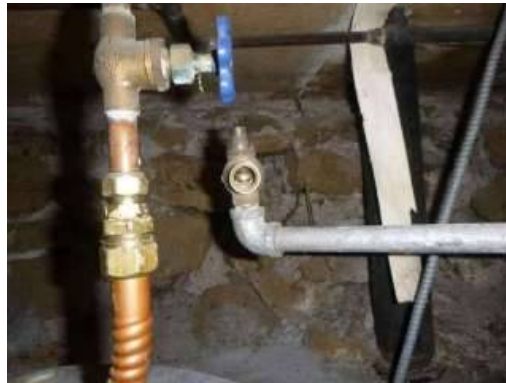
**38) Safety, Repair/Replace** - No drain line was installed for the temperature-pressure relief valve. This is a potential safety hazard due to the risk of scalding if someone is standing next to the water heater when the valve opens. Recommend that a qualified plumber install a drain line per standard building practices.

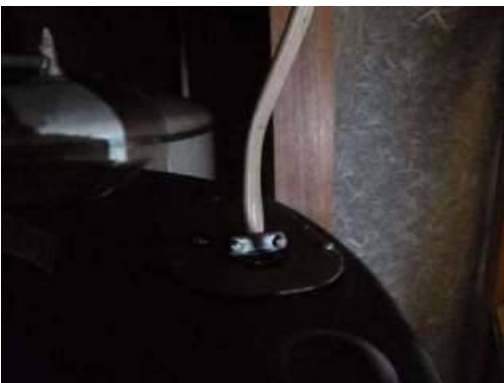
Photo 39-1

**39) Safety, Repair/Replace** - Wiring for the water heater's power supply was exposed and subject to damage. Standard building practices call for non-metallic sheathed wiring to be protected with BX armored conduit to prevent damage. This is a potential safety hazard for shock. Recommend that a qualified contractor repair per standard building practices.

Exposed wire is present at the Rudd water heater.

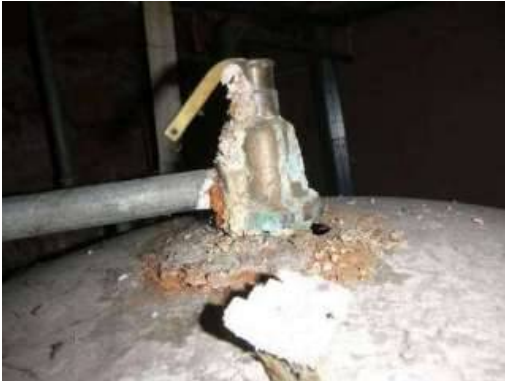
Photo 40-1

**40) Repair/Replace, Evaluate** - Significant corrosion or rust was found at the supply pipes or fittings. This can indicate past leaks, or that leaks are likely to

Significant corrosion is present at the TPR valve of the National water heater.

occur in the future. Recommend that a qualified plumber evaluate and replace components or make repairs as necessary.

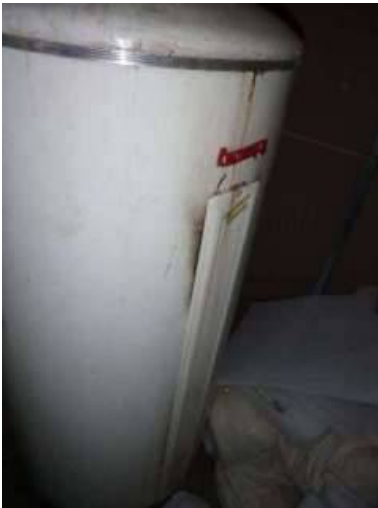
Photo 41-1

**41) Evaluate, Comment** - The estimated useful life for most water heaters is 8-12 years. The inspector was unable to determine the age of the water heater due to the manufacturer's label being obscured, no serial number being visible, or the serial number not clearly indicating the age. The client should be aware that this water heater may be near, at or beyond its useful life and may need replacing at any time. Recommend attempting to determine the water heater's age.

The National water heater appears to be very old and shows soot at the element cover.

If found to be near, at or beyond its useful lifespan, recommend budgeting for a replacement in the near future, or considering replacement now before any leaks occur. The client should be aware that significant flooding can occur if the water heater does fail. If not replaced now, consider having a qualified person install a catch pan and drain or a water alarm to help prevent damage if water does leak.

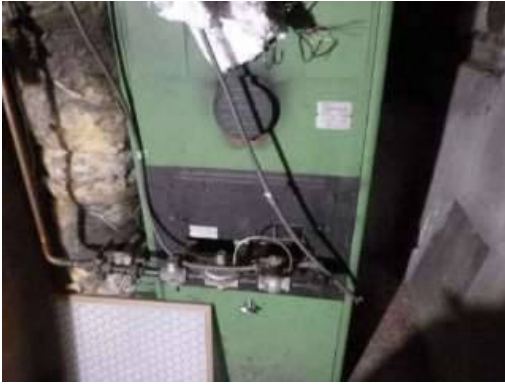
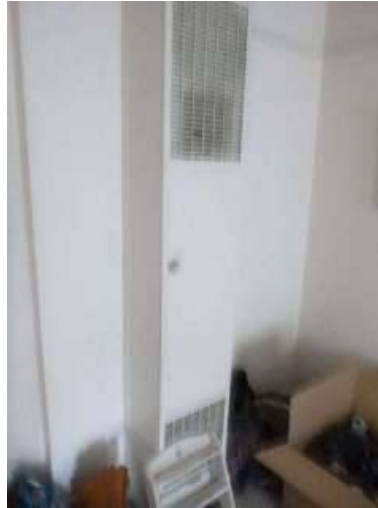
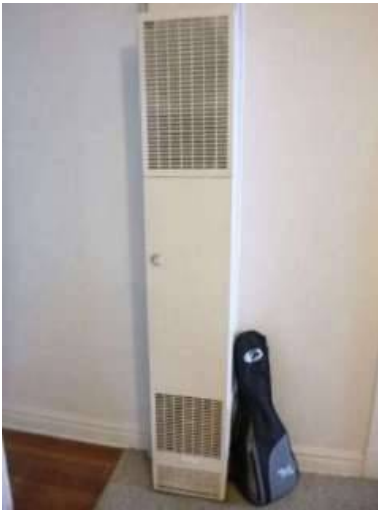
**43) Evaluate, Comment** - The estimated useful life for most forced air furnaces is 15-20 years. The inspector was unable to determine the age of the furnace. Be aware that this furnace may be near, at, or beyond its useful life and may need replacing or significant repairs at any time. Recommend attempting to determine the furnace's age (ask property owner or service technician), and budgeting for a replacement if necessary.

All of the furnaces appear to be old.

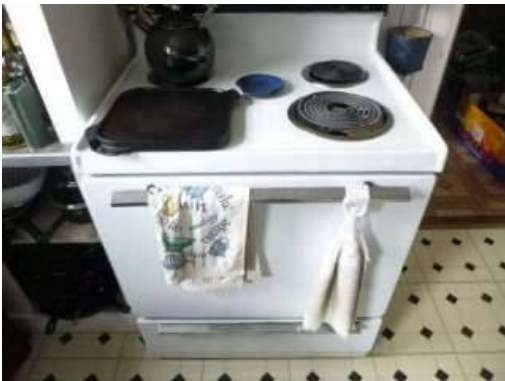
Photo 44-1

**44) Safety, Repair/Replace** - The range could tip forward. An anti-tip bracket may not be installed. This is a potential safety hazard since the range can tip forward when weight is applied to the open door, such as when a small child climbs on it or if heavy objects are dropped on it. Anti-tip brackets have been sold with all free-standing ranges since 1985. Recommend installing an anti-tip bracket to eliminate this safety hazard. For more information, visit:

Both apartment ranges do not have an anti-tip bracket.

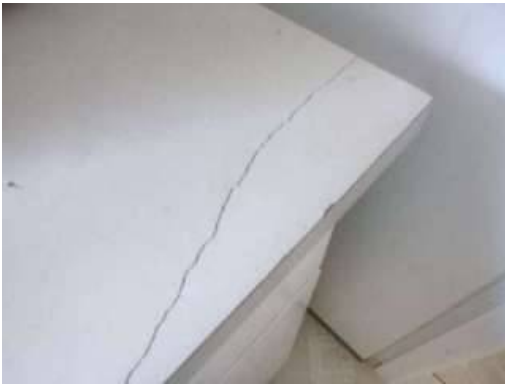
Photo 45-1

**45) Repair/Replace** - Countertops and/or backsplashes were damaged or deteriorated. Recommend repairing or replacing as necessary. The upstairs counter is damaged.

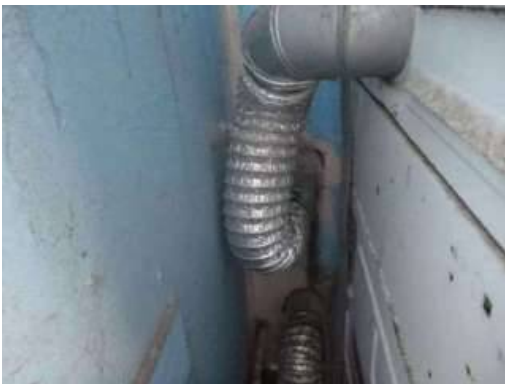
Photo 46-1

**46) Safety, Repair/Replace** - The clothes dryer was equipped with a vinyl or mylar, accordion-type, flexible exhaust duct. The U.S. Consumer Product Safety Commission considers these types of ducts to be unsafe, and a fire hazard. They can trap lint and are susceptible to kinks or crushing, which can greatly reduce the air flow and cause overheating. Recommend that such ducts be replaced with a rigid or corrugated semi-rigid metal duct, and by a qualified contractor if necessary. For more information, visit:

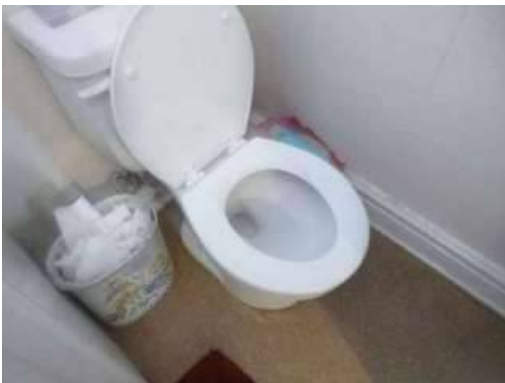
Photo 47-1

**47) Repair/Replace, Evaluate** - The toilet at location(s) #A was loose where it attached to the floor. Leaks can occur. Flooring, the sub-floor or areas below may get damaged. Sewer gases can enter living spaces. Recommend that a qualified contractor remove the toilet(s) for further evaluation and repair if necessary. A new wax ring should be installed and toilet(s) should be securely anchored to the floor to prevent movement and leaking.

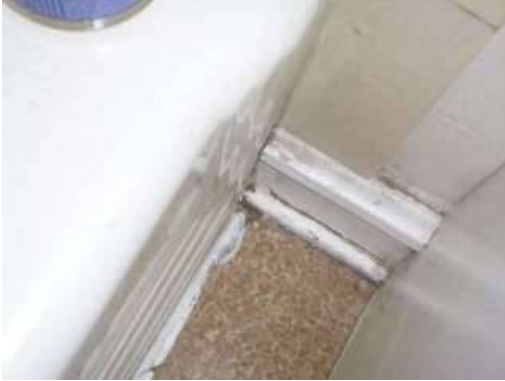
Photo 49-1

**49) Repair/Maintain** - Gaps, no caulk, or substandard caulking were found between the bathtub and the walls at location(s) #B. Water may penetrate these areas and cause damage. Recommend that a qualified person re-caulk or install caulking as necessary.

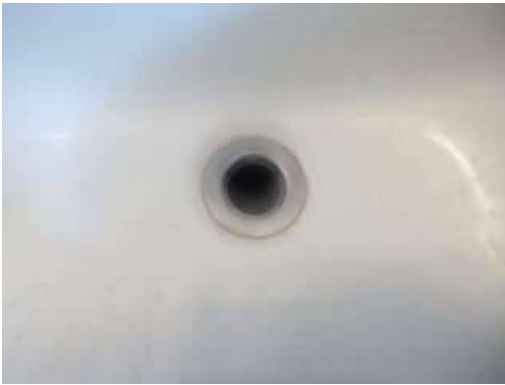
Photo 50-1

**50) Repair/Maintain** - The sink drain stopper mechanism at location(s) #B was missing. Recommend that a qualified person repair or replace as necessary.

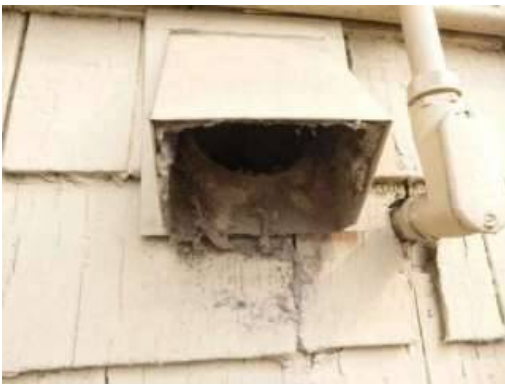
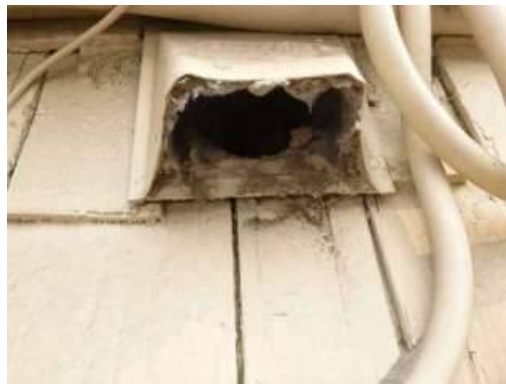
**51) Repair/Maintain** - The clothes dryer exhaust duct was broken in one or more places. Clothes dryers produce large amounts of moisture which should not enter structure interiors. Moisture can accumulate and result in mold, bacteria or fungal growth. Recommend that a qualified person make permanent repairs as necessary. For more information, visit:

The exterior vent covers are missing their flaps.
